Technical Preservation Services
Preservation Assistance Division
National Park Service
U.S. Department of the Interior
Washington, D.C.

Interpreting the Secretary of the Interior's Standards for Rehabilitation

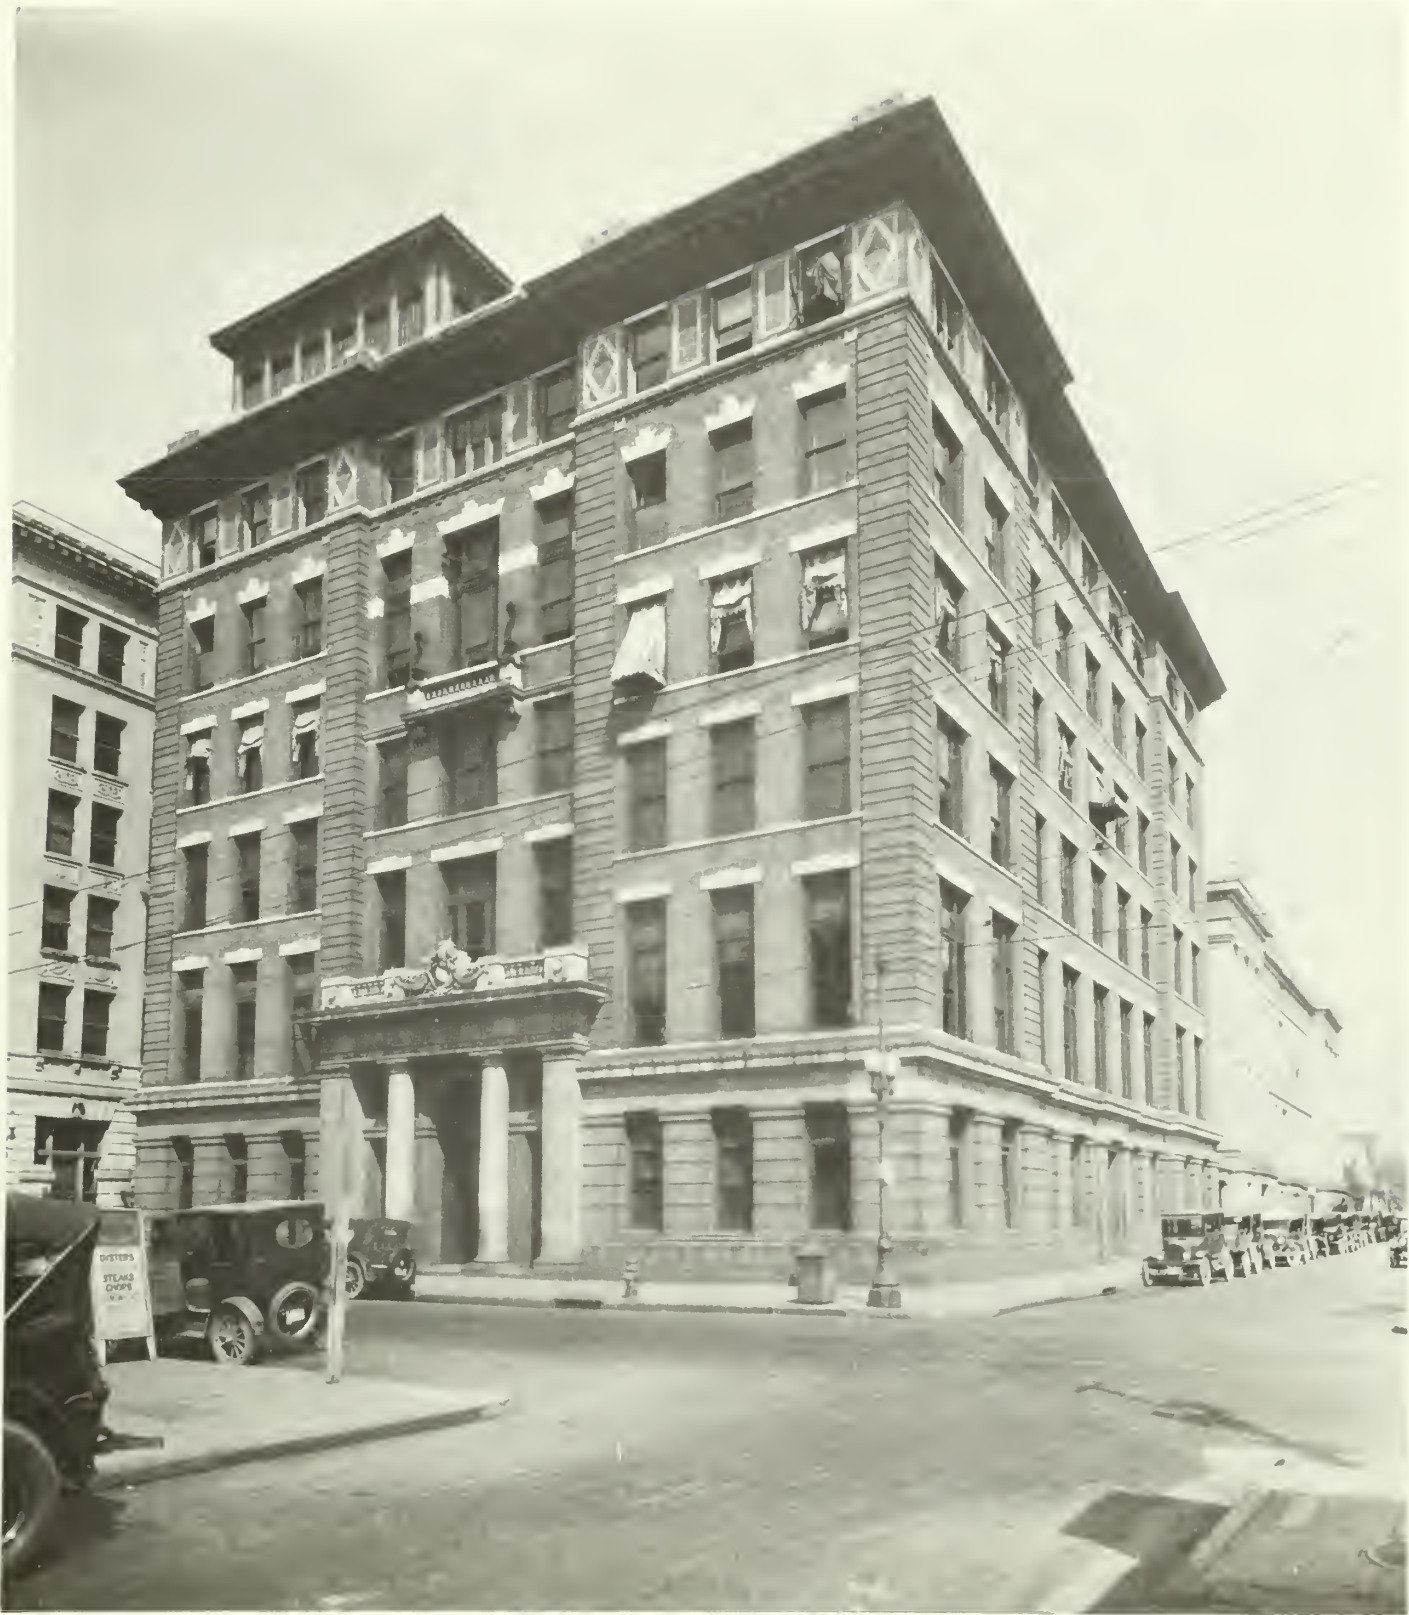
1. This former City Hall, shown here in a 1925 photograph, has changed little over the years on the exterior with the exception of an old rooftop addition off to the left. The building has a prominent corner location and is highly visible not only at the intersection of two busy thoroughfares but also from down the streets as well.

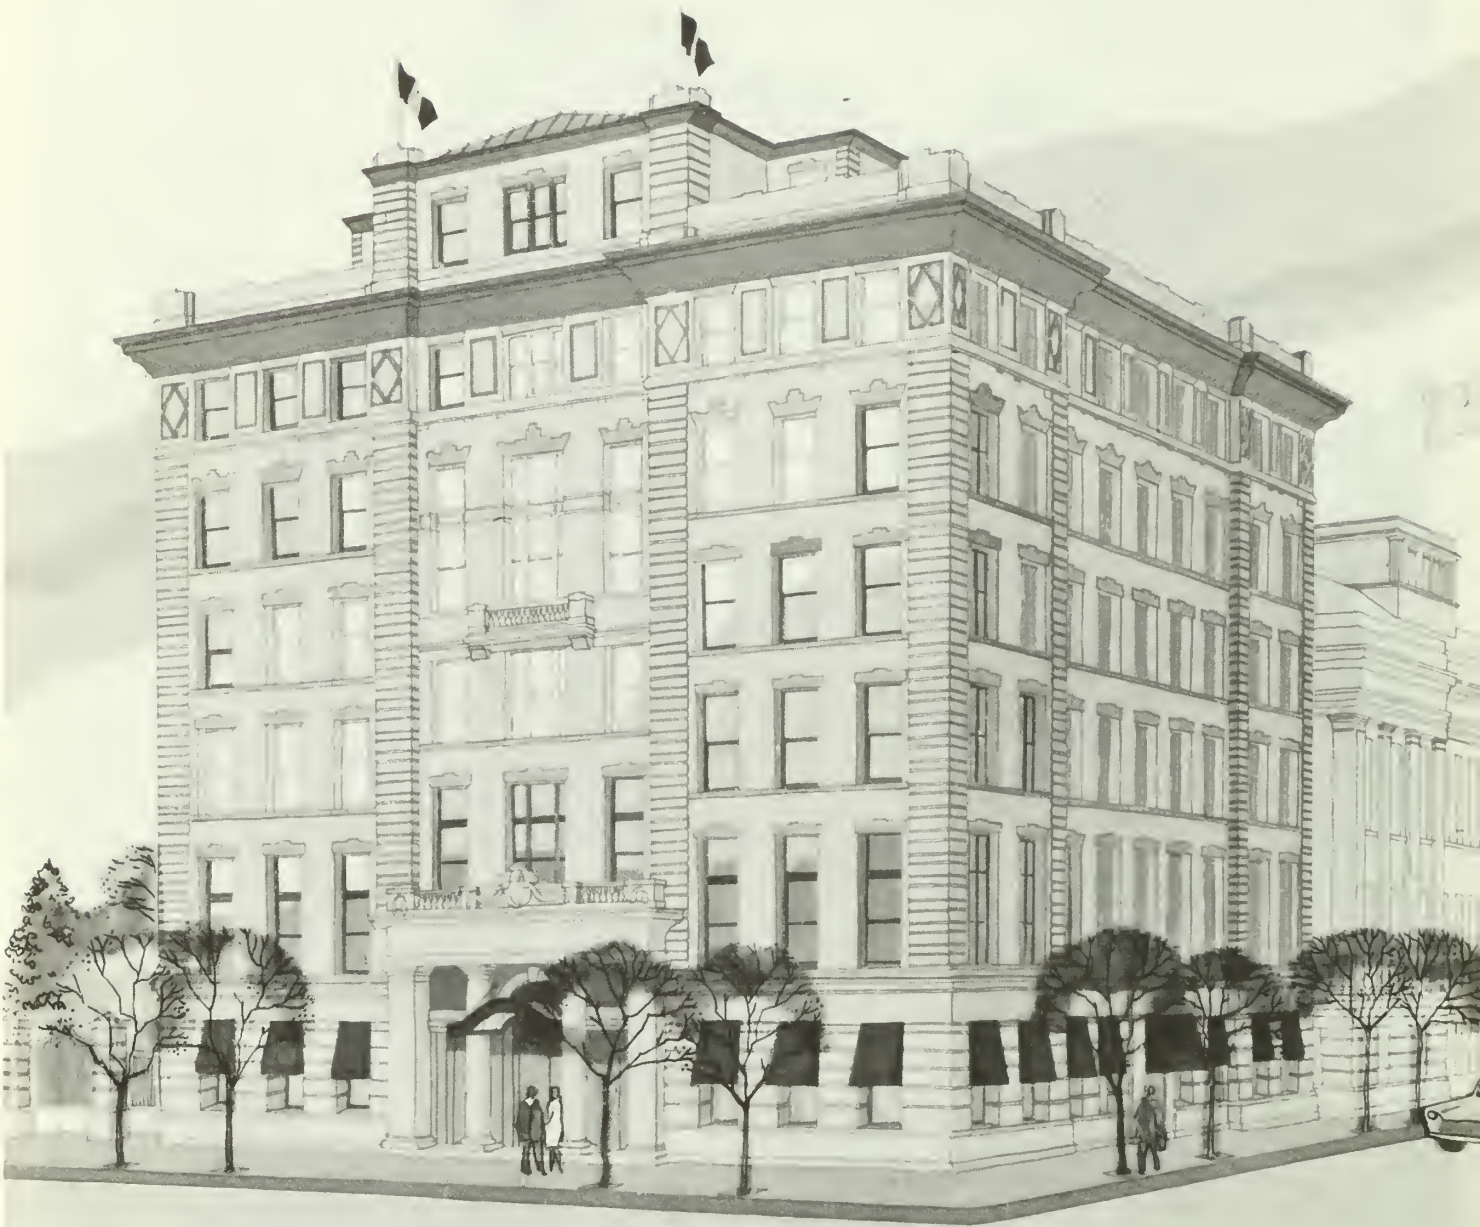
2. The proposed penthouse addition with the three bay portion across the front was determined not to meet the Standards for Rehabilitation. The change in the form of the building; the conscious attempt to tie the addition to the historic building through use of replicative detailing; and the alterations to the historic roof balustrade, were all factors cited by the National Park Service.

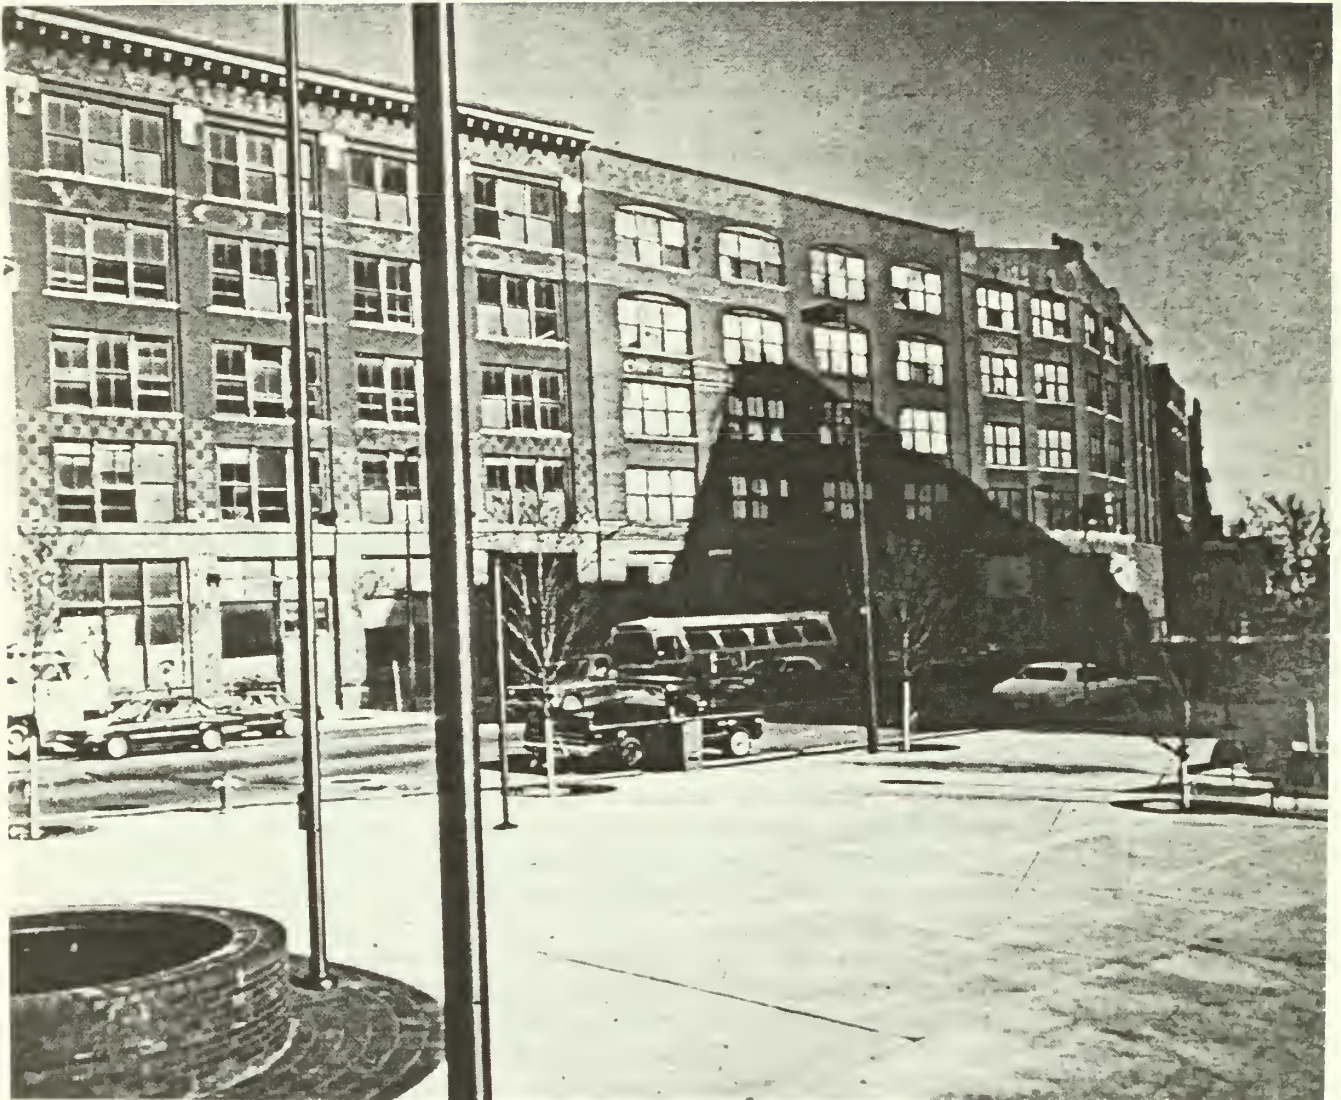
1. Case No.1: This view is looking south along the major street. Note the bend in the warehouse row as the buildings follow this road. This two block row of eight buildings is the last remaining row of industrial warehouses in the city.

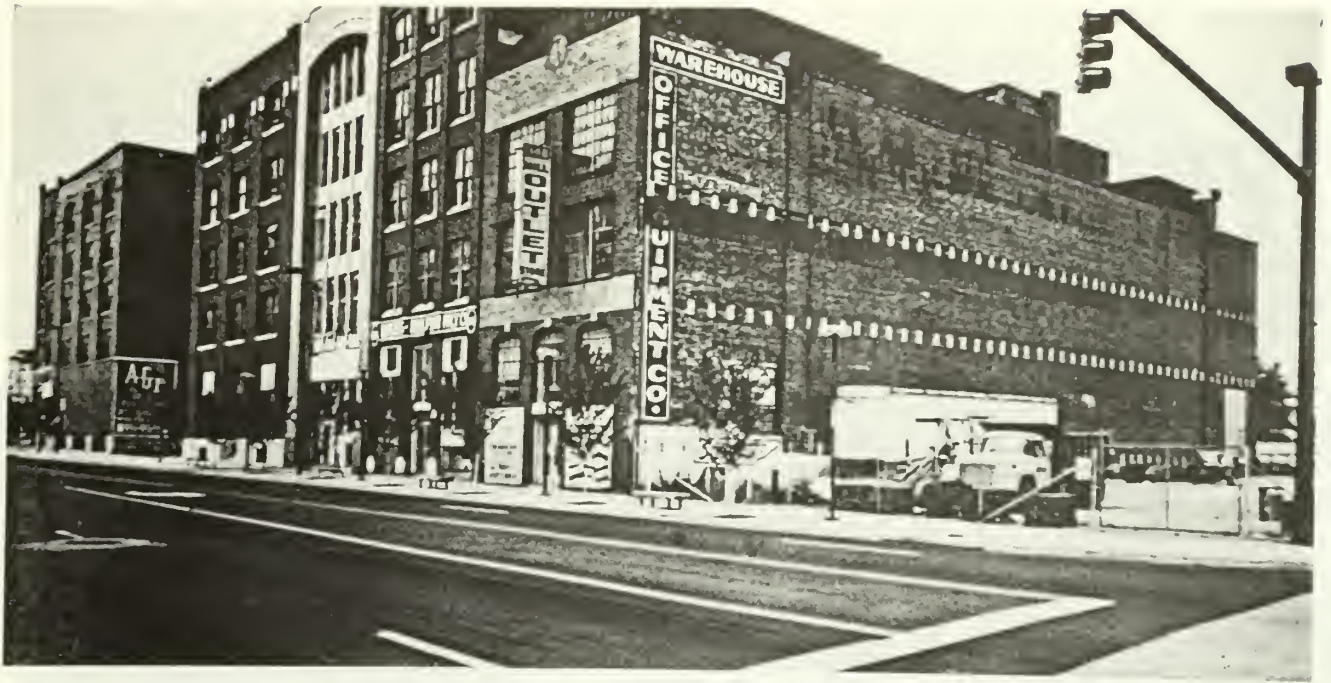
2. This view of a portion of the historic district is looking north. Note the road which divides the district into two blocks. This is the site of the proposed new addition and "pedway."
